Drainage Master Plan

Project # 120-11872-000

December 2016

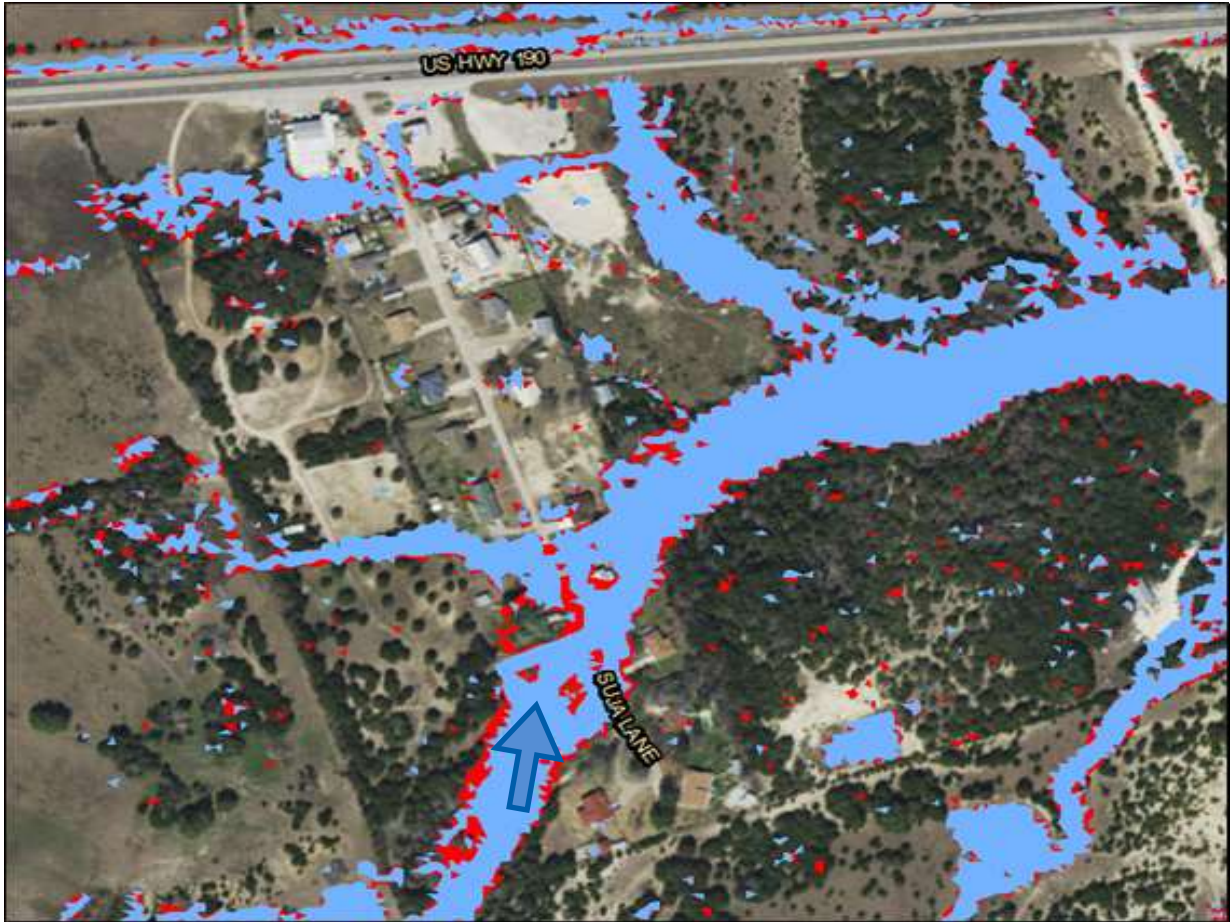
Project Number:	CC19
Project Name:	Suja Lane
Description:	City & Citizen Identified - street and property flooding at culvert at Suja Ln 2-year storm flow = 300 cfs 18" pipe capacity < 20 cfs
Solution:	Re-grade channel from elevation 1118 to elevation 1104; 35-ft top width, 10-ft bottom width, 4-ft deep with 3:1 side slopes and 0.0119 longitudinal slope to carry 10-year storm Replace southern 18" pipe with four 4' x 4' RCBs to safely pass 2-year storm
Recommendation:	Mandate that proposed development to the southwest (upstream) detain any increase in runoff to maintain current drainage conditions. An alternative solution at this site might be to contribute a portion, or all, of these funds to a joint use detention facility upstream and over-detain stormwater runoff. Additional study is required to determine the effectiveness at Suja Lane.
Results:	Alleviate street flooding and property flooding

Problem Type:	Flooding
Location:	South quadrant; Suja Ln culverts and drainage channels
Sources of Water:	Clear Creek basin

This project is located in Clear Creek watershed at the Suja Lane. Citizens and City staff identified street and property flooding at the culverts near the end of the street. It was confirmed that the 2-year storm flow in this area is over 300 cfs, while the two 18-inch diameter pipe culverts have a combined capacity of less than 40 cfs. It is recommended that the main channel be re-graded from elevation 1118 to 1104 to a 35-ft top width, 4-ft deep section with 3 to 1 horizontal to vertical side slopes and 10-ft bottom width to carry the 10-year storm. If the 18-inch pipe to the south is replaced with four 4-ft by 4-ft RCBs the culvert will safely pass the 2-year storm. This solution will alleviate the street and property flooding in the area and the estimated cost of this project is \$311,558.

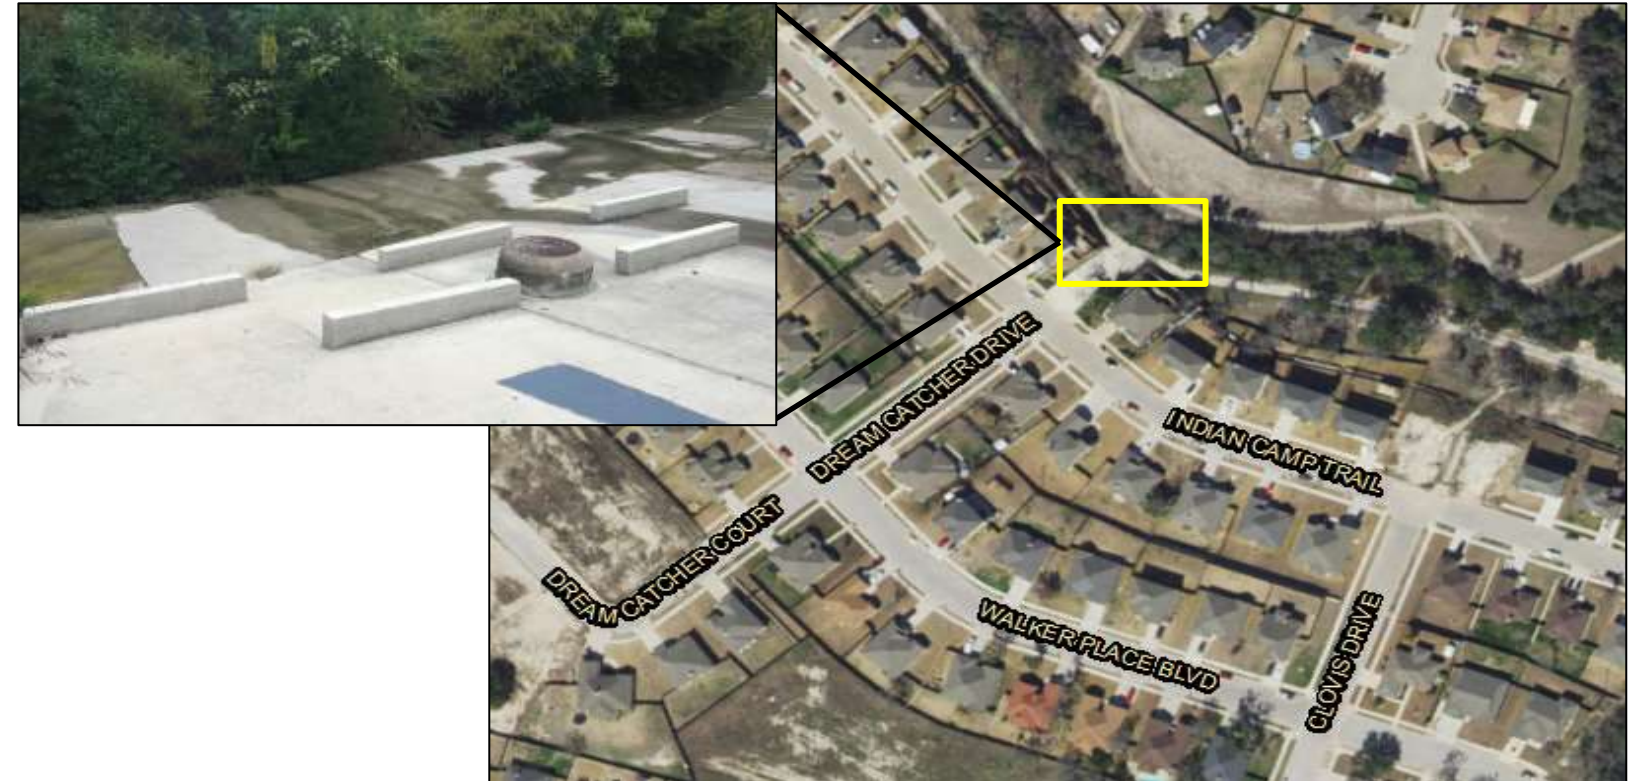
Results:	Reduce slipping/falling hazard on SUP

Problem Type:	Safety
Location:	South quadrant; Shared Use Path behind 1612 Indian Camp Trail
Sources of Water:	Clear Creek basin

This project is located in Clear Creek watershed at the shared use path (SUP) behind 1612 Indian Camp Trail. Citizens, City staff, and LAN staff identified flooding and algae growth on the SUP caused by groundwater seepage and low flow from the storm drain apron; water from the backyard at 1612 Indian Camp Trail may be seeping out from beneath the retaining wall and also contributing to the algae growth. The solution to this problem consists of two steps, the first of which is to remove the algae growth and seal the concrete with a water-repelling sealant including an anti-skid additive. If the first step does not alleviate the safety hazard, it is recommended that a v-notch concrete ditch be installed from the backyard at 1612 Indian Camp Trail and at the joint between the baffle apron and SUP parallel to the SUP, eventually turning across the SUP, and out-falling to the creek. The portion of the v-ditch perpendicular to the SUP will be covered with a metal grate. The estimated cost of Phase 1 of this project is \$2,313, and the estimated cost of Phase 2 is \$11,380.

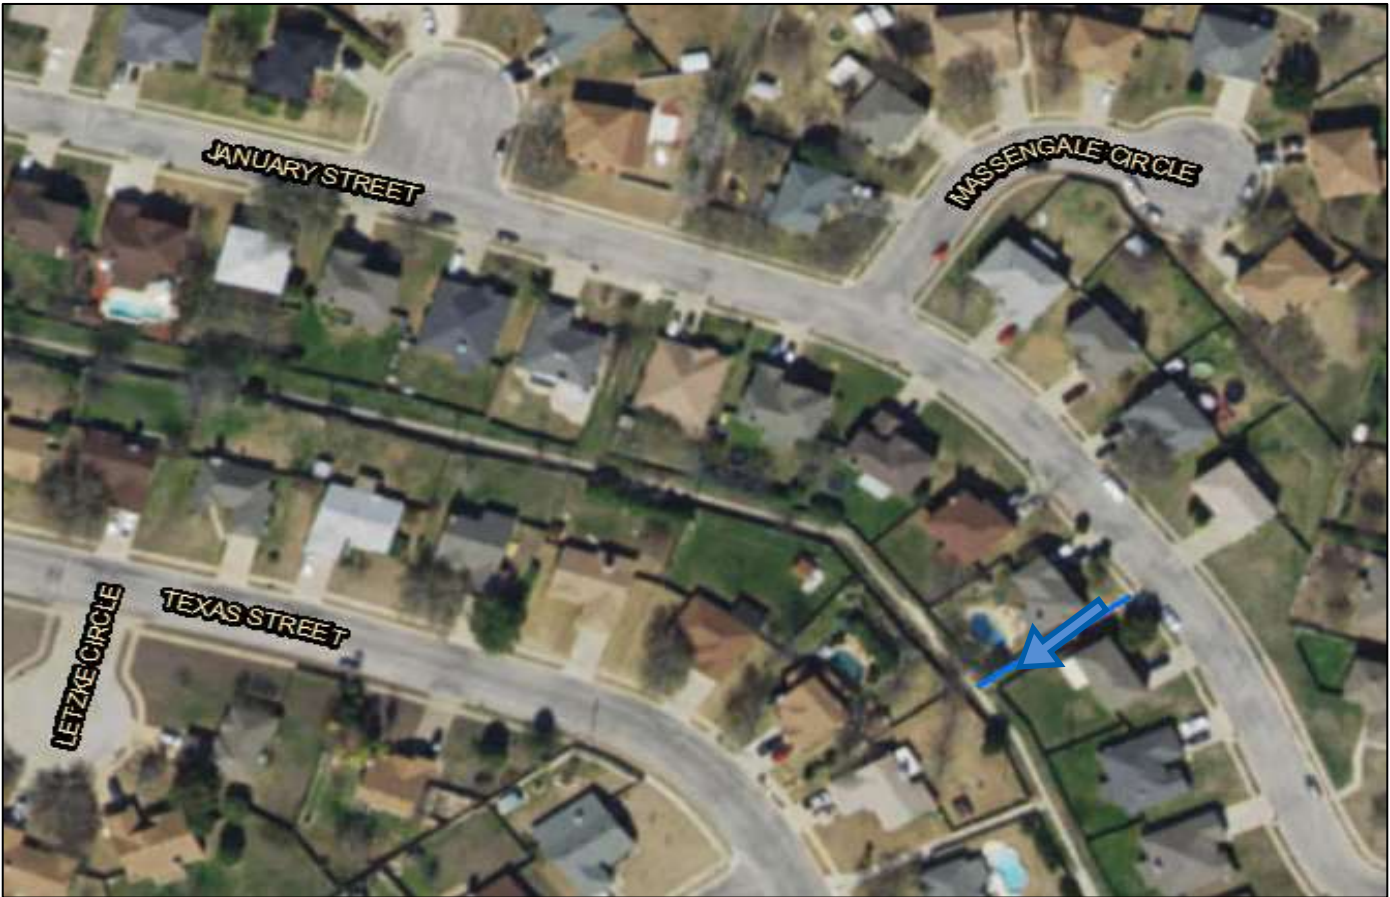
Sources of Water:

Turkey Run basin

This project is located in Turkey Run watershed at the earthen drainage flume next to 224 January Street. Citizens identified property flooding and erosion of the flume between homes. LIDAR data indicates that there is a high point along the flow line of the flume close to the street. It is recommended that the flume be re-graded to a 10-ft wide, 0.5-ft deep section with a consistent longitudinal slope and lined with concrete. This will alleviate the flooding and erosion and achieve design uniformity with other flumes between properties in the area. The estimated cost of this project is \$28,762.
